DEFENCE RESEARCH BOARD

PROJECT HI-MOVE - 1964

FINAL REPORT

Report No. DR 174

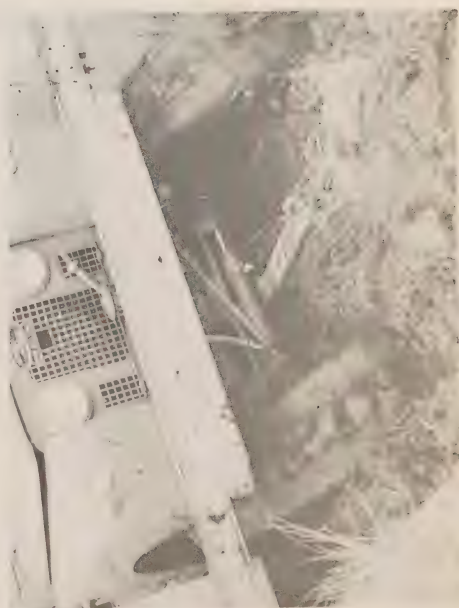
Fig. 22.

The tracked Land Rover completed 32 passes, although producing 6-in. ruts along most of the test lane. Most difficulty occurred where a patch of I intruded and, as this was thought to give an anomalous result, the vehicle was allowed to continue testing in the FI(E) portion. At 40 passes, immobilization seemed imminent, and tests were continued until, on the 49th pass, the vehicle had to be recovered by the Water Buffalo. Penetrometer indices were similar to the above. Subsidence values (Table 1) do not reflect conditions at the site of immobilization, where the surface mat was completely removed and the vehicle unable to obtain traction on the remolded amorphous-granular peat below (Fig. 22).

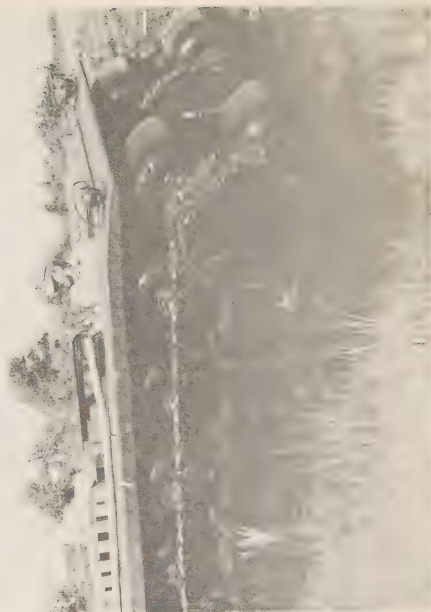
Fig. 27.

The Airoll was tested in FI(E) at the edge of Dinner Lake. It completed 50 passes easily although there was a tendency for peat and surface material to build up on the roller drive sprockets (Fig. 27) and, on one occasion, to force the chain off the sprocket. Backwards and forwards maneuvering replaced the chain. The area is much wetter than the FI(E) at Cranberry Lake and the peat became quite fluid. The surface mat also is deeper than that of the test lanes at Cranberry Lake so that even when ruts had reached a depth of 18 in. the vehicle still gained some support from fibrous material.

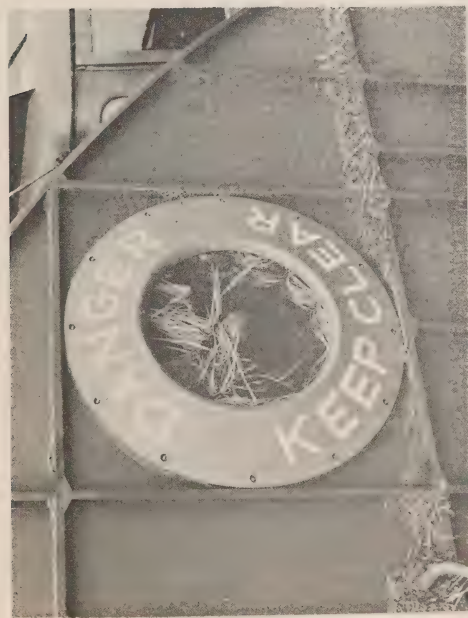
Fig. 28.

The Hovertruck was tested in FI(E) in Area 10G and completed 26 passes before the fan drive belt disintegrated. (This failure also occurred during a preliminary test). Ruts about a foot deep formed and shredded vegetation blocked the radiator, partially blocked the air intake (Fig. 28) and, when the vehicle stopped, burned on the exhaust.

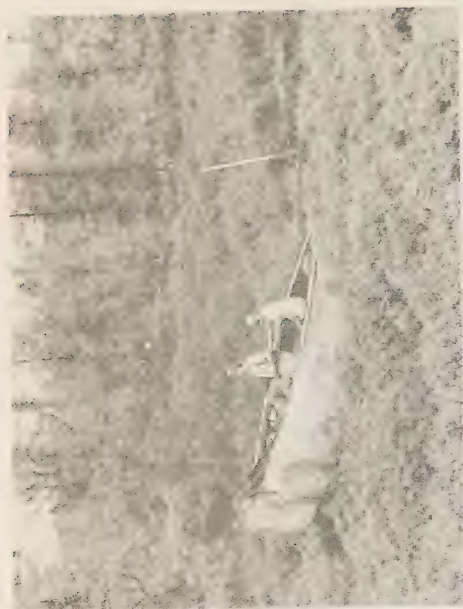
Fig. 33.

The main EI site presented extremely difficult conditions. The Water Buffalo was immobilized at one point (Fig. 33), and winched itself out. The variation in strength of the surface mat and the presence of mounds, hollows, and channels is well demonstrated by the pitching and rolling of vehicles seen in the film made during the trials.

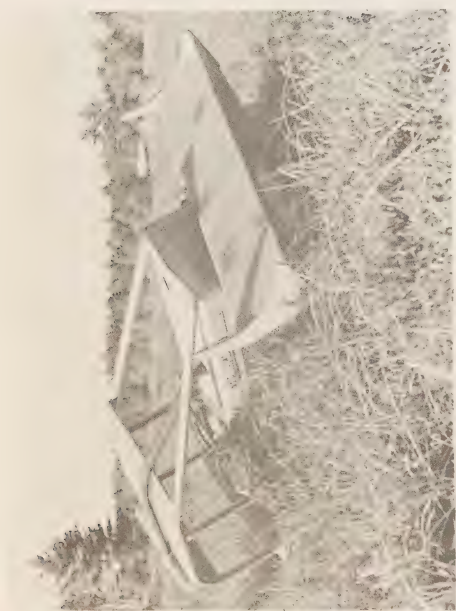
Fig. 32.

The Timberjack foundered on its way to the lane (Fig. 32) and was recovered by the Water Buffalo. It completed eight passes reasonably well. There was some rolling on mounds and hollows, and rut depth increased to about 1 ft. Conditions deteriorated until the 12th pass, when the test was discontinued because the Water Buffalo was not available for recovery. It was thought that immobilization might have occurred within the next five passes.

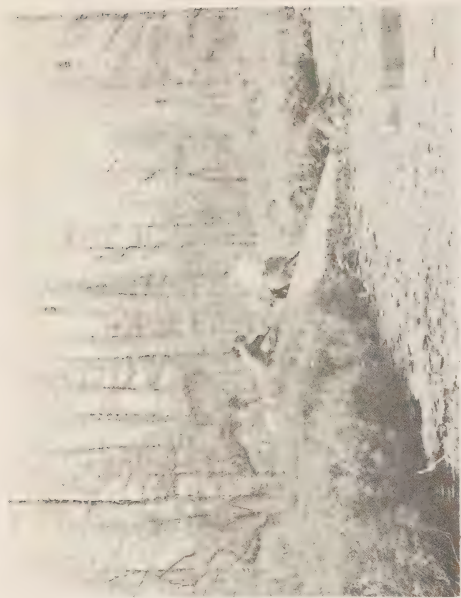
Fig. 41.

In attempting to mount an EI mat the vehicle rode up on a submerged obstacle, backed off, shipped water over the stern and sank (Fig. 40). It was retrieved by the Water Buffalo (Fig. 41). The windshield was damaged beyond repair (Fig. 42) and a spring shackle on the suspension needed to be welded, but the engine and transmission functioned normally after being drained, dried and replenished with oil.

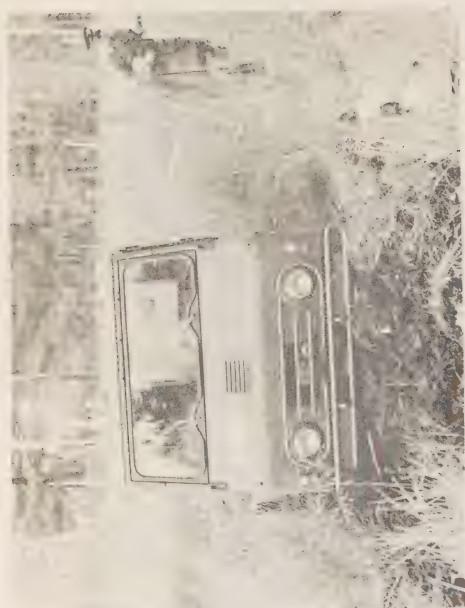
Fig. 49.

The Jeep and Volvo performed in almost identical manner, both negotiating all obstacles until reaching the beaver channel on the east side of the lake (Figs. 2 and 49). Both were retrieved and continued without incident to complete the course. The Volvo driver appeared to have a more comfortable ride. Average speeds (based on running time) reflect the slow rate of progress imposed by course conditions, but the fuel consumption figures are affected by several minutes idling time and by repeated attempts to extricate vehicles from the beaver channel.
